Investigation of a mach 1.4 compressor  
cascade with variable back pressure using  
flow visualization.

INVESTIGATION OF A MACH 1.4 COMPRESSOR  
CASCADE WITH VARIABLE BACK PRESSURE  
USING FLOW VISUALIZATION

Michael George Hegland

March 1986

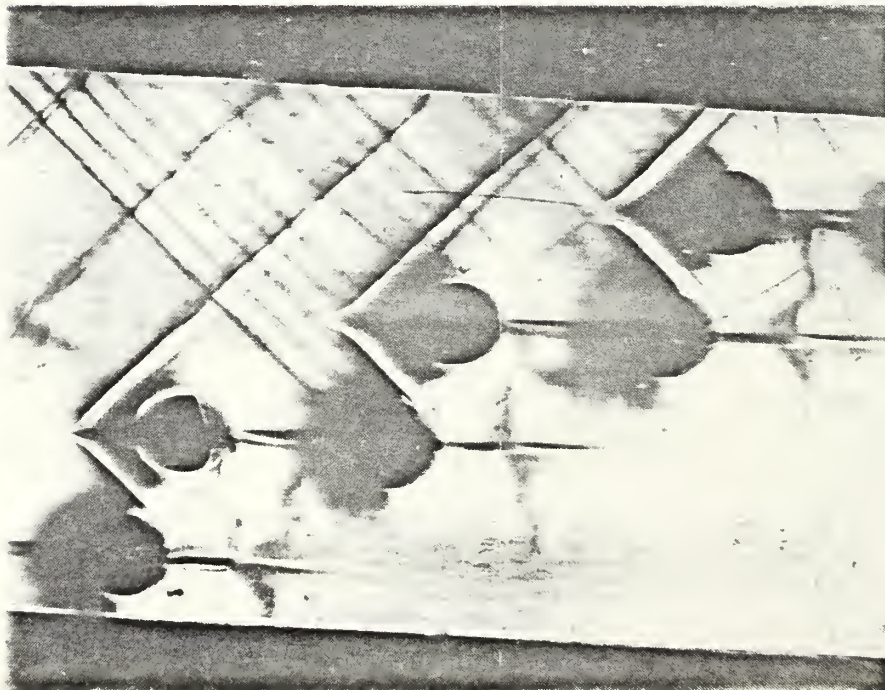
Figure 11. Cascade Flow at  $0.91^\circ$  Incidence

a. Unrestricted Porous Wall Bleed

b. Optimum Porous Wall Bleed

Small differences in flow structure through the two center blade passages can be seen in Figures 10 and 11. The differences involve slightly different shock impingement points on the suction surface of the lower blade in each passage, and consequently differences in the impingement of the reflected shocks on the pressure surfaces at the top of each passage. It is noted that at  $M = 1.4$ , a change in shock

Cancellation of reflected waves was found to occur independent of porous wall mass flow control. Mass flow control was effective in minimizing the strength of the Mach waves generated by the porous wall (contrast Figures 10a with 10b and 11a with 11b for example). Optimum wall bleed rate was found to be a function of blade incidence and test section back pressure. Figure 10c illustrates partial test section unststarting caused by excessive restriction of the porous wall mass flow. The porous wall provides compensation for test section physical and viscous blockage in addition to wave cancellation. Unststarting in Figure 10c was attributed to restriction of porous wall bleed to the point where insufficient blockage compensation was provided.

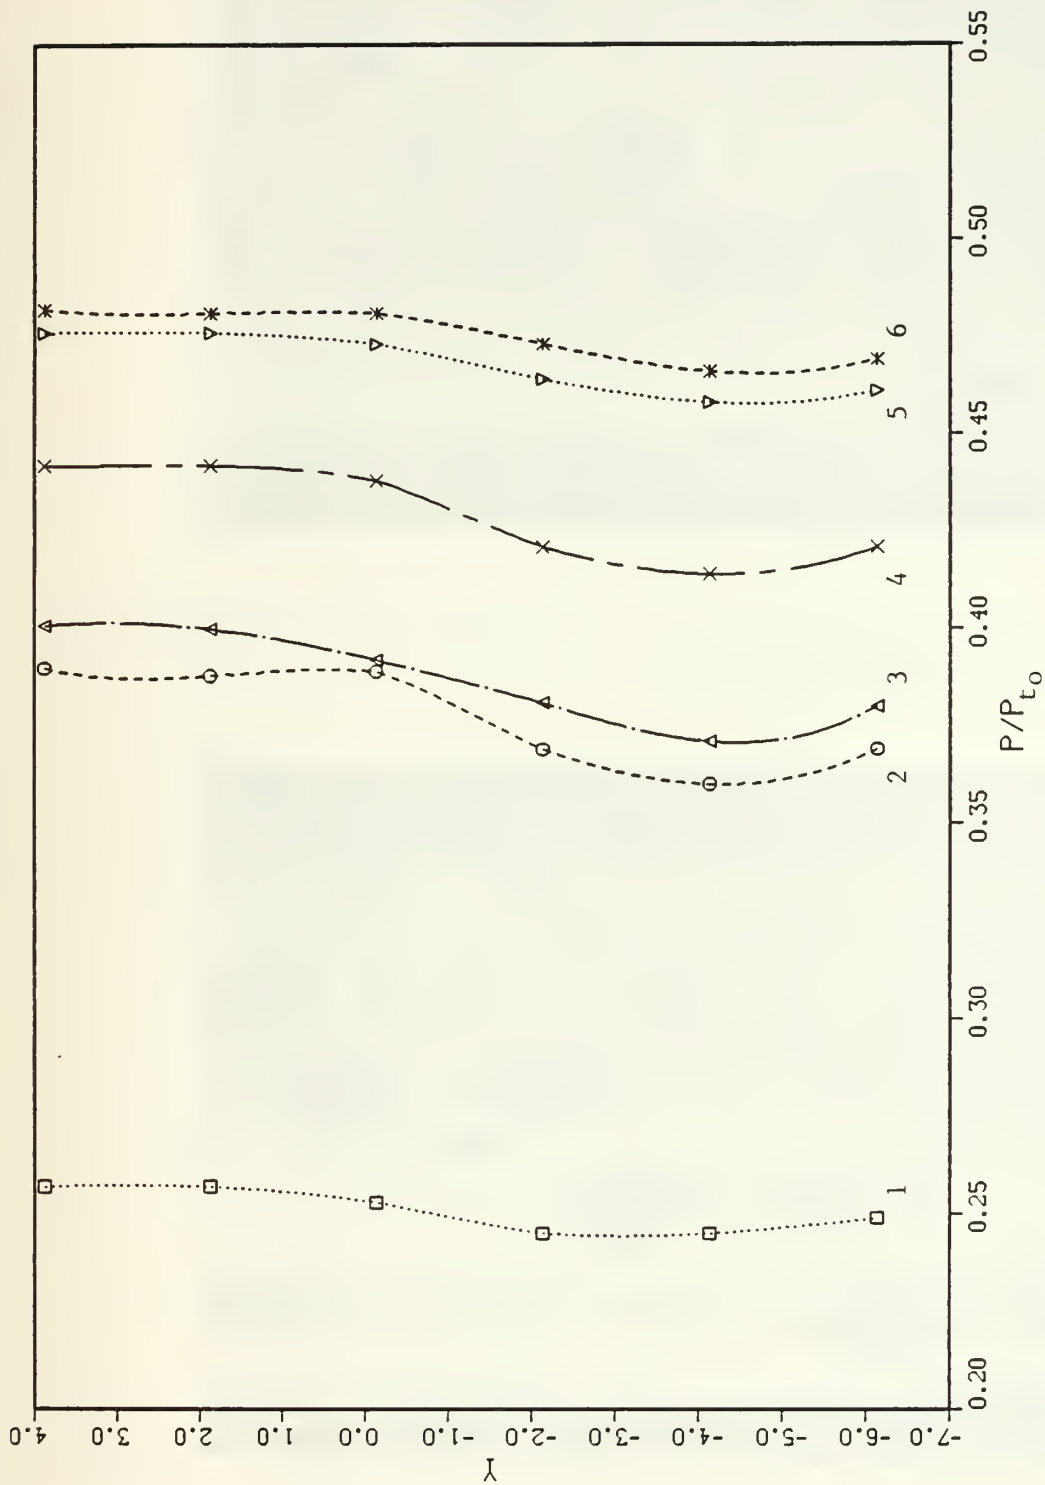
Figure 12. Outflow Static Pressure Variation with Back Pressure  
Control Valve Setting (1. Ramp Down, 0% Drum; 2. Ramp  
Up, 0% Drum; (3-6). Increasing Drum Displacement)

Figure 12 shows an example of the variation in outlet static pressure during a test run. Blade row static pressure ratios varied from 0.78 to 1.51 for the data in this figure. Schlieren photographs corresponding to conditions 2 and 6 of Figure 12 are shown in Figures 13 and 14 respectively.
